**DRAFT FINAL**  
**Coal Ash Impoundment**  
**Specific Site Assessment**  
**Report**  
**Arizona Public Service**  
**Cholla Power Plant**

Submitted by:  
**GEI Consultants, Inc.**  
6950 South Potomac Street, Suite 300  
Centennial, CO 80112

October 2009  
Project 091330

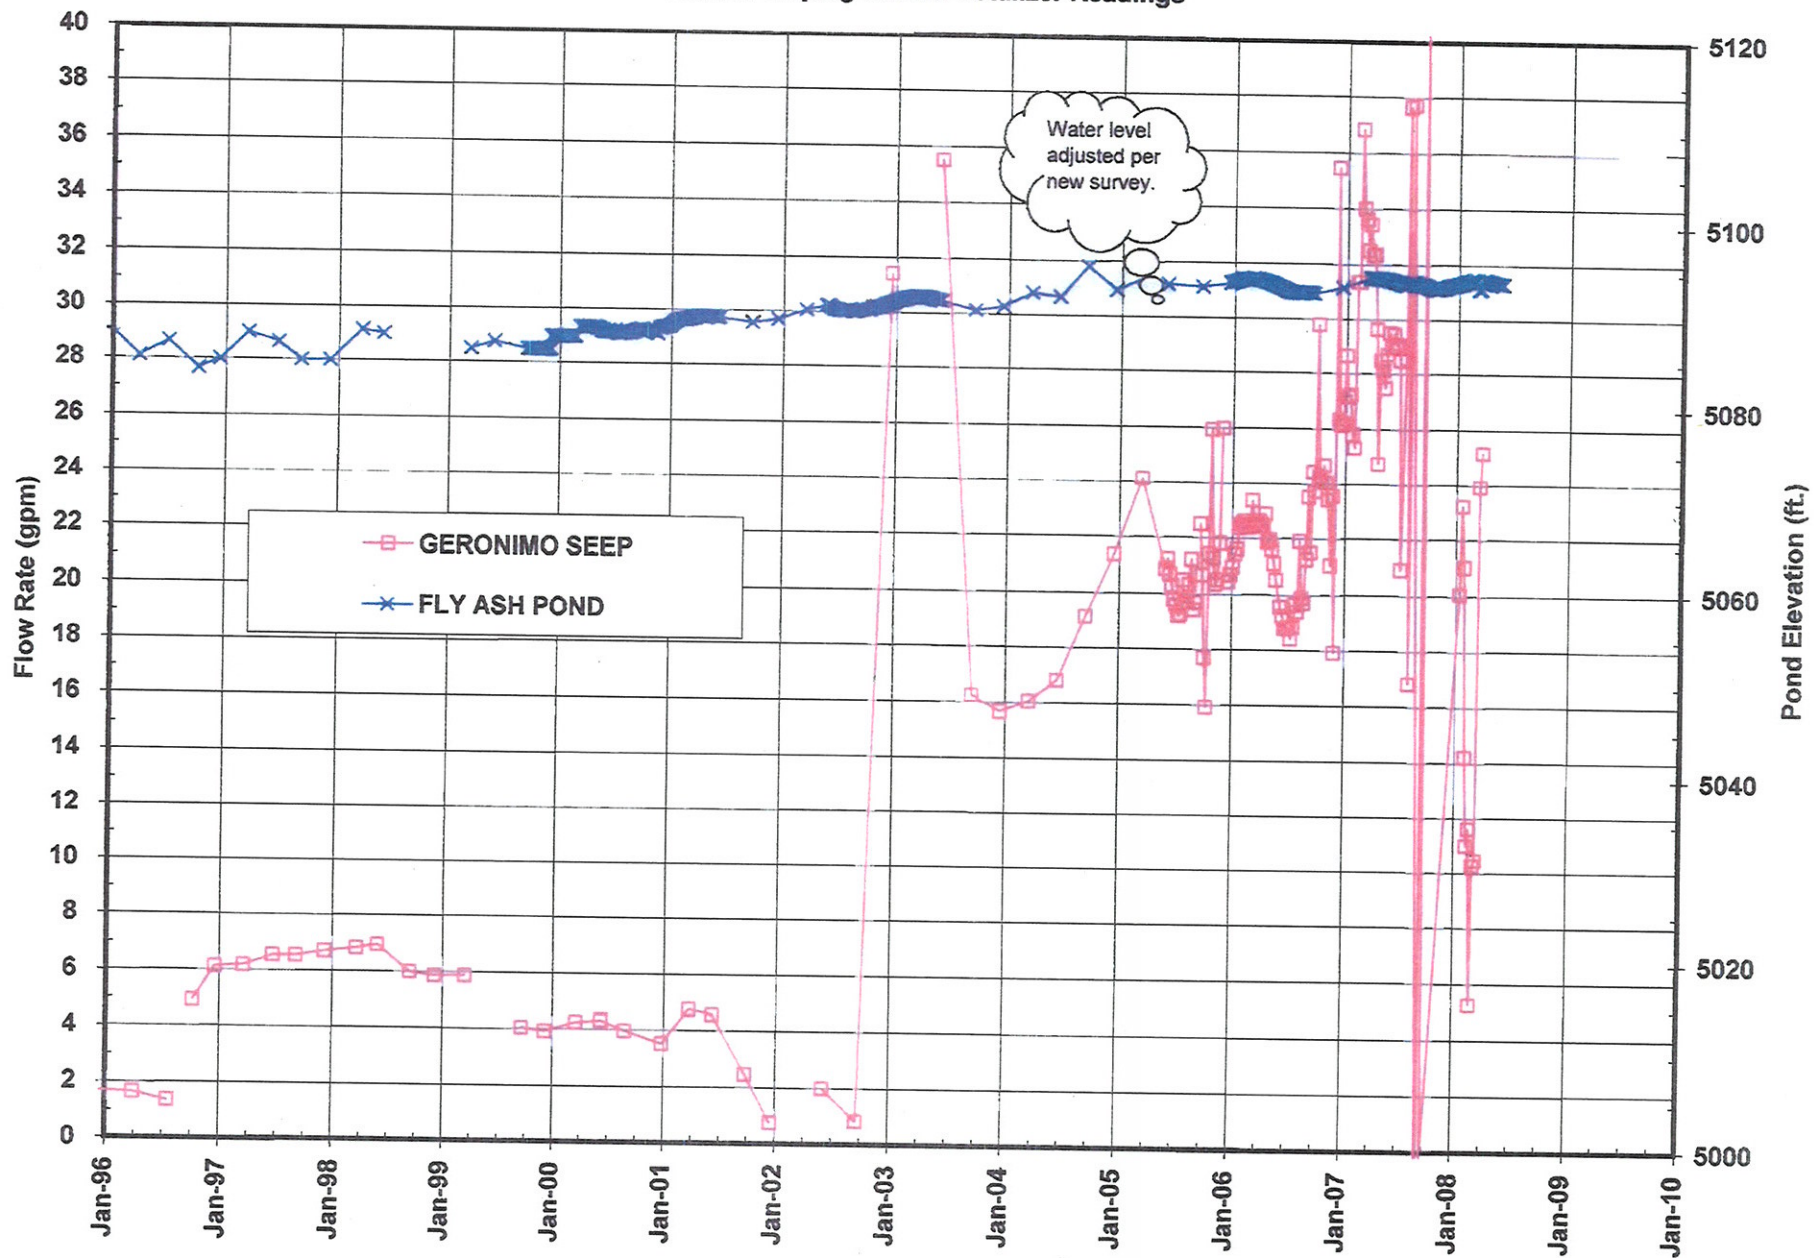
The seepage totalizers at the Geronimo and Hunt Seeps show widely fluctuating readings with maximum seepage quantities up to 47 gpm at the Geronimo Seep and 12 gpm at the Hunt Seep. The Geronimo Seep is very close to the toe of the dam and therefore seepage quantities as high as 47 gpm could be of concern with regard to dam stability. APS should repair or replace the seepage totalizers as soon as possible to determine the actual quantity of seepage at the Geronimo Seep. If it is still relatively high, an investigation of the seepage origin should be undertaken and stability analyses completed in order to determine whether seepage of this magnitude could compromise dam stability. The turbidity measured in the Geronimo Seep has apparently been low since the equipment malfunction was corrected, but turbidity measurements should be closely monitored.

# CHOLLA FLY ASH DAM

The instrumentation installed at the Fly Ash Pond Dam is thorough and considered adequate. The frequency of readings is also adequate. The totalizers at the Geronimo and Hunt Seeps should be repaired so they can again provide a reliable measure of seepage.

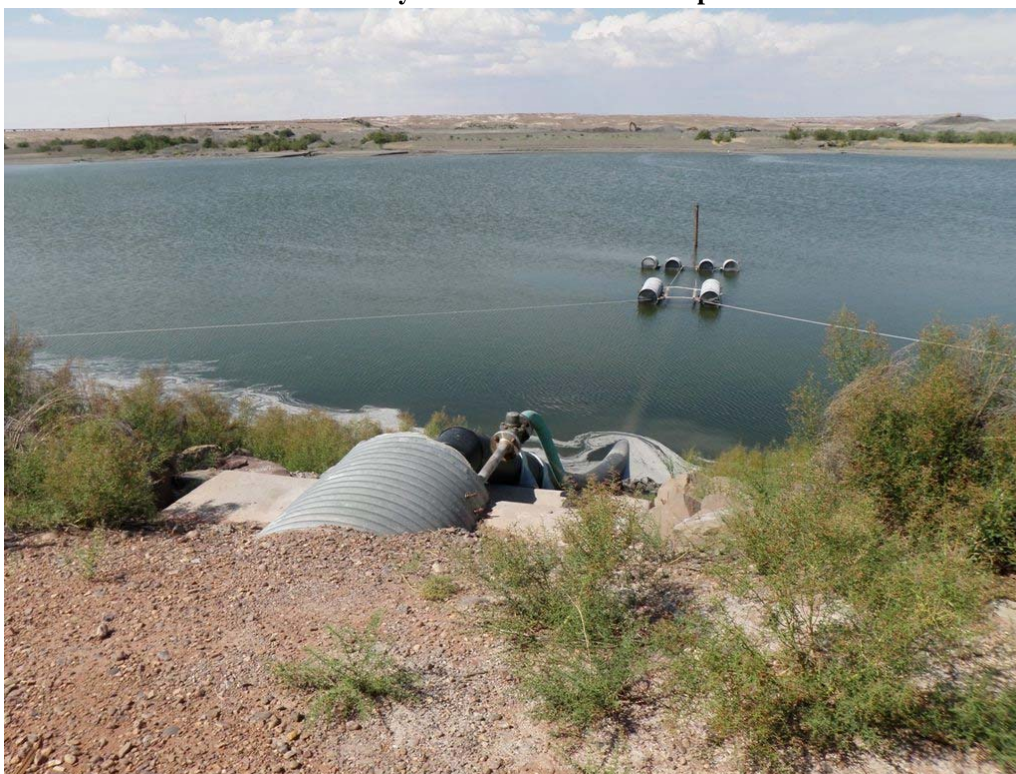
There was no obvious evidence of settlement observed during the assessment in either embankment. An investigation of cracking in the Fly Ash Pond Dam was completed in 2001, and six survey monuments were added at this time to monitor potential movement in the area of cracking. The monuments have indicated that minor settlement (about 0.2 feet in 8 years) is taking place. The cracking is located around the maximum section of the dam, where the largest magnitude of settlement has occurred over the life of the dam (about 1.7 feet). The eastern, saddle portion of the dam is adjacent to the area of cracking and this area has settled a maximum of about 0.7 feet over the life of the dam. It is, therefore, possible that differential settlement has contributed to cracking in the dam crest. However, the amount of settlement is within the range expected for a dam as large as the Fly Ash Pond Dam, and it does not appear to be a threat to dam safety.

**Photo 35 – Fly Ash Pond: Buoy marking 300-foot distance from area where cracks were observed in embankment crest. Fly ash beach must extend upstream of this distance.**
